4.

Competing Against Time: Report of the Governor's Board of Inquiry on the 1989 Loma Prieta Earthquake

George W. Housner, HM.EERI, and Charles C. Thiel, Jr., M.EERI

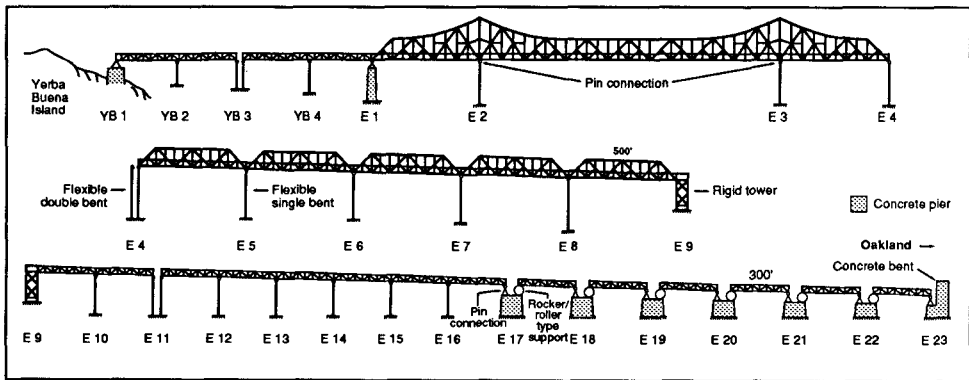
Figure 2. The east sections of the San Francisco-Oakland Bay Bridge showing support conditions

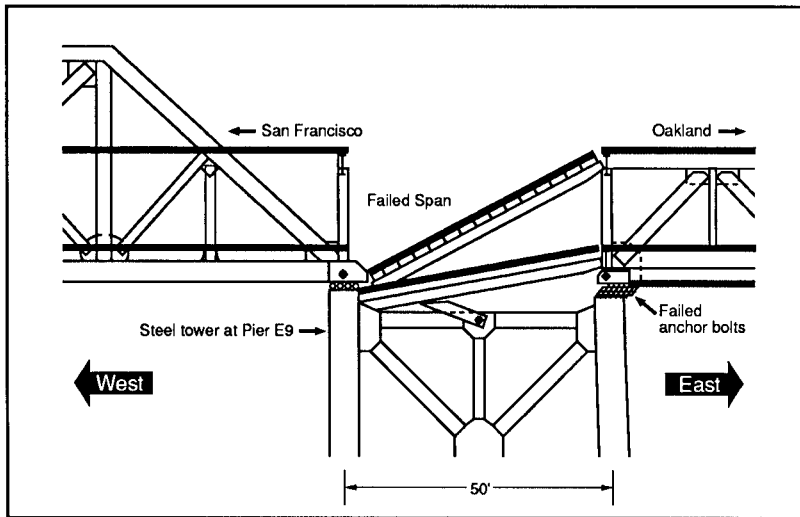
The principal earthquake damage to the bridge was the failure of the upper and lower closure spans at Pier E9. It was closed for one month for repair. These 50 foot long upper and lower closure spans fell when the bolts failed that connected the pier and the 290' truss to the east (Figure 4). Another span at Pier E23, close to the eastern edge of the bridge, was near failure of a comparable type. Connections at Piers E18-E23 also failed. The concrete pedestal bases of Pier E17 cracked when the pier rocked back and forth and incurred some damage at the corners.

Figure 4. The upper and lower closure spans fell when the bolts attaching the east (right) truss-span were severed and it moved to the east, pulling the link spans off their western supports.

The closure spans linking the two long-span trusses on each side of pier E9 were supported on five inches of bearing on six-inch wide seat-type expansion joints at the west end and bolted connections at the east end. When the truss to the east broke free from its support, the closure spans were pulled with it, and the motions were large enough to slide them off the five-inch seats. As a result, the spans hinged down under gravity load, with the upper span

The approximate five-inch permanent displacement of the eastern span relative to Pier E9 was removed by jacking the trusses back into place. High strength bolts were used to attach the trusses to the pier, and larger seats for the replacement closure spans were installed. The trusses at Piers E18 through E22 were also jacked back into position and connected to the piers with high strength bolts. Replacement restrainers were installed at these locations. The seismic adequacy of these repairs, and of the bridge itself, in the event of a severe earthquake needs to be investigated and any necessary long-term seismic upgrading completed expeditiously.

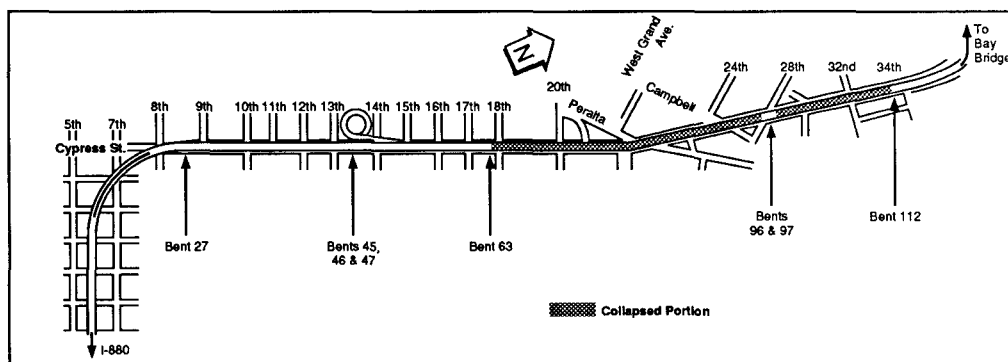
Figure 5. The Cypress Viaduct showing the extent of the collapse.

Failure occurred in the lower girder-to-column joints on both sides of a bent, with initial failure in the short column stub above the top of the lower deck and below the shear key. The failure surface was defined by the plane of the curved negative moment reinforcement bent down into the joint. The shear key did not fail in pure shear, as evidenced by the cone of concrete still attached to the four #10 bars that extended through the key into the lower column. The upper girder-to-column joint sometimes failed completely, but in other cases was just severely cracked. Almost all the damage in this upper joint seems to have been produced as a result of the collapse of the upper deck onto the lower deck. The #4 transverse ties in the joint region, as well as those in the column region, either failed or were severely damaged. Examples of this type of bent failure are Bents 63-69, Bents 81-94, and Bents 99-103.

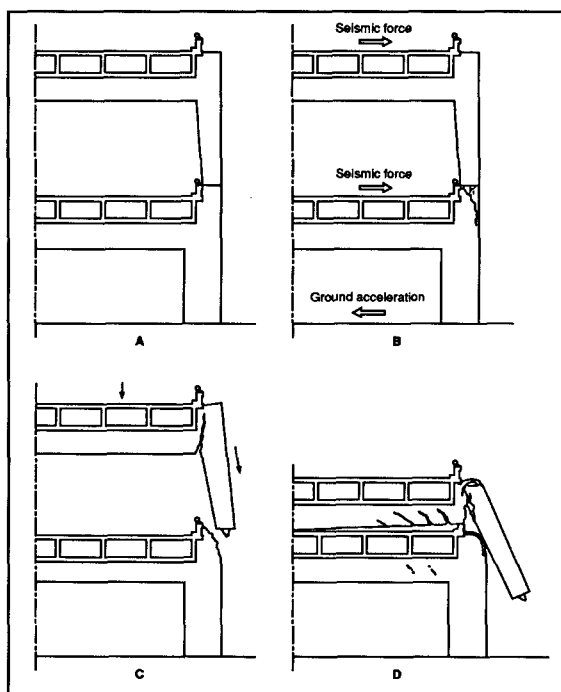
The common failure mode is illustrated by the sequence shown in Figure 6. A diagonal crack formed in the stub and lower girder-to-column joint regions. This crack followed a plane of weakness in the joint region defined by the plane of the bent-down negative moment girder reinforcement. Then the gravity and seismic forces pushed the upper column down and away from the joint, resulting in the collapse of the upper deck. Much of the damage to the upper columns, roadway, and girders was subsequently caused by the impact of the upper deck on the lower deck. Experiments performed on standing portions of the Cypress as well as static and dynamic analyses indicate that the calculated seismic demands during the Loma Prieta earthquake required to initiate failure in this nonductile structure were greater than the available structural capacities.

Figure 6. Typical failure sequence of the prevalent style bent (B1). All but seven of the 48 collapsed bents failed in this way. For further discussion see the Report and Nims et al, [10].

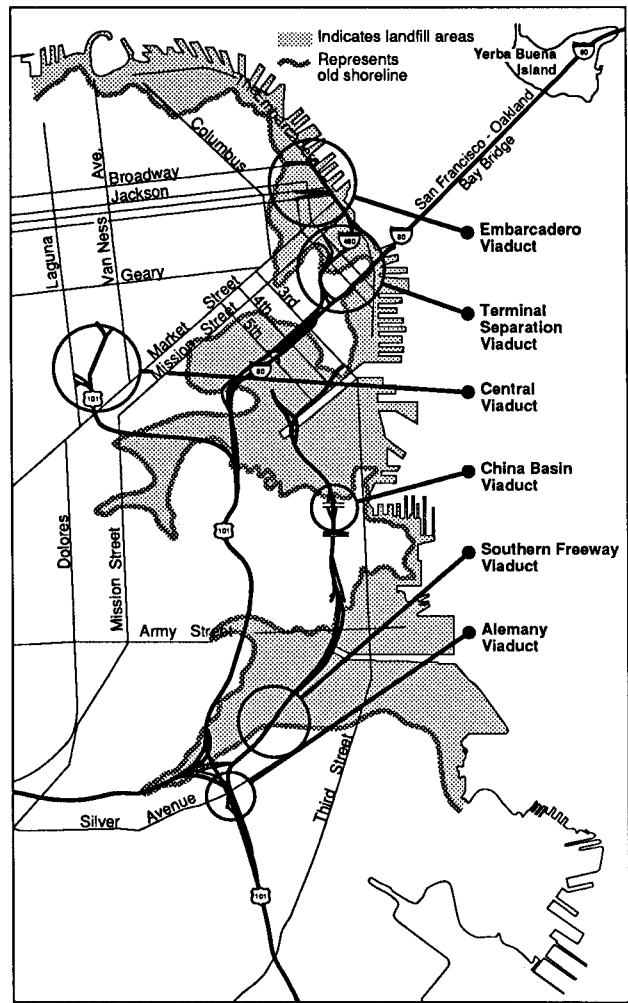
Damage to the individual viaducts varied and included shear cracking in columns, girders, and joints; torsional cracking in outrigger bents; anchorage failure of the girder reinforcement; and shear key failure, among others. Many of the crack patterns are similar to those observed in the collapsed and damaged portions of the Cypress Viaduct.

Figure 7. Location of the damaged San Francisco Freeway Viaducts .

After the 1989 earthquake, Caltrans retained six consultants to prepare contract documents for the upgrading of the six designated freeway structures. The criteria set by Caltrans for the development of the upgrading schemes were outlined in a series of letters and memoranda and included requirements for the analysis of the freeway structures and interpretation thereof, and design and detailing requirements. The damage criteria set by Caltrans accepts serious damage, but not collapse, during severe earthquake shaking. These designs were latter reviewed by a Caltrans appointed independent review panel, at the suggestion of the Board, and at this writing under substantial discussion.
